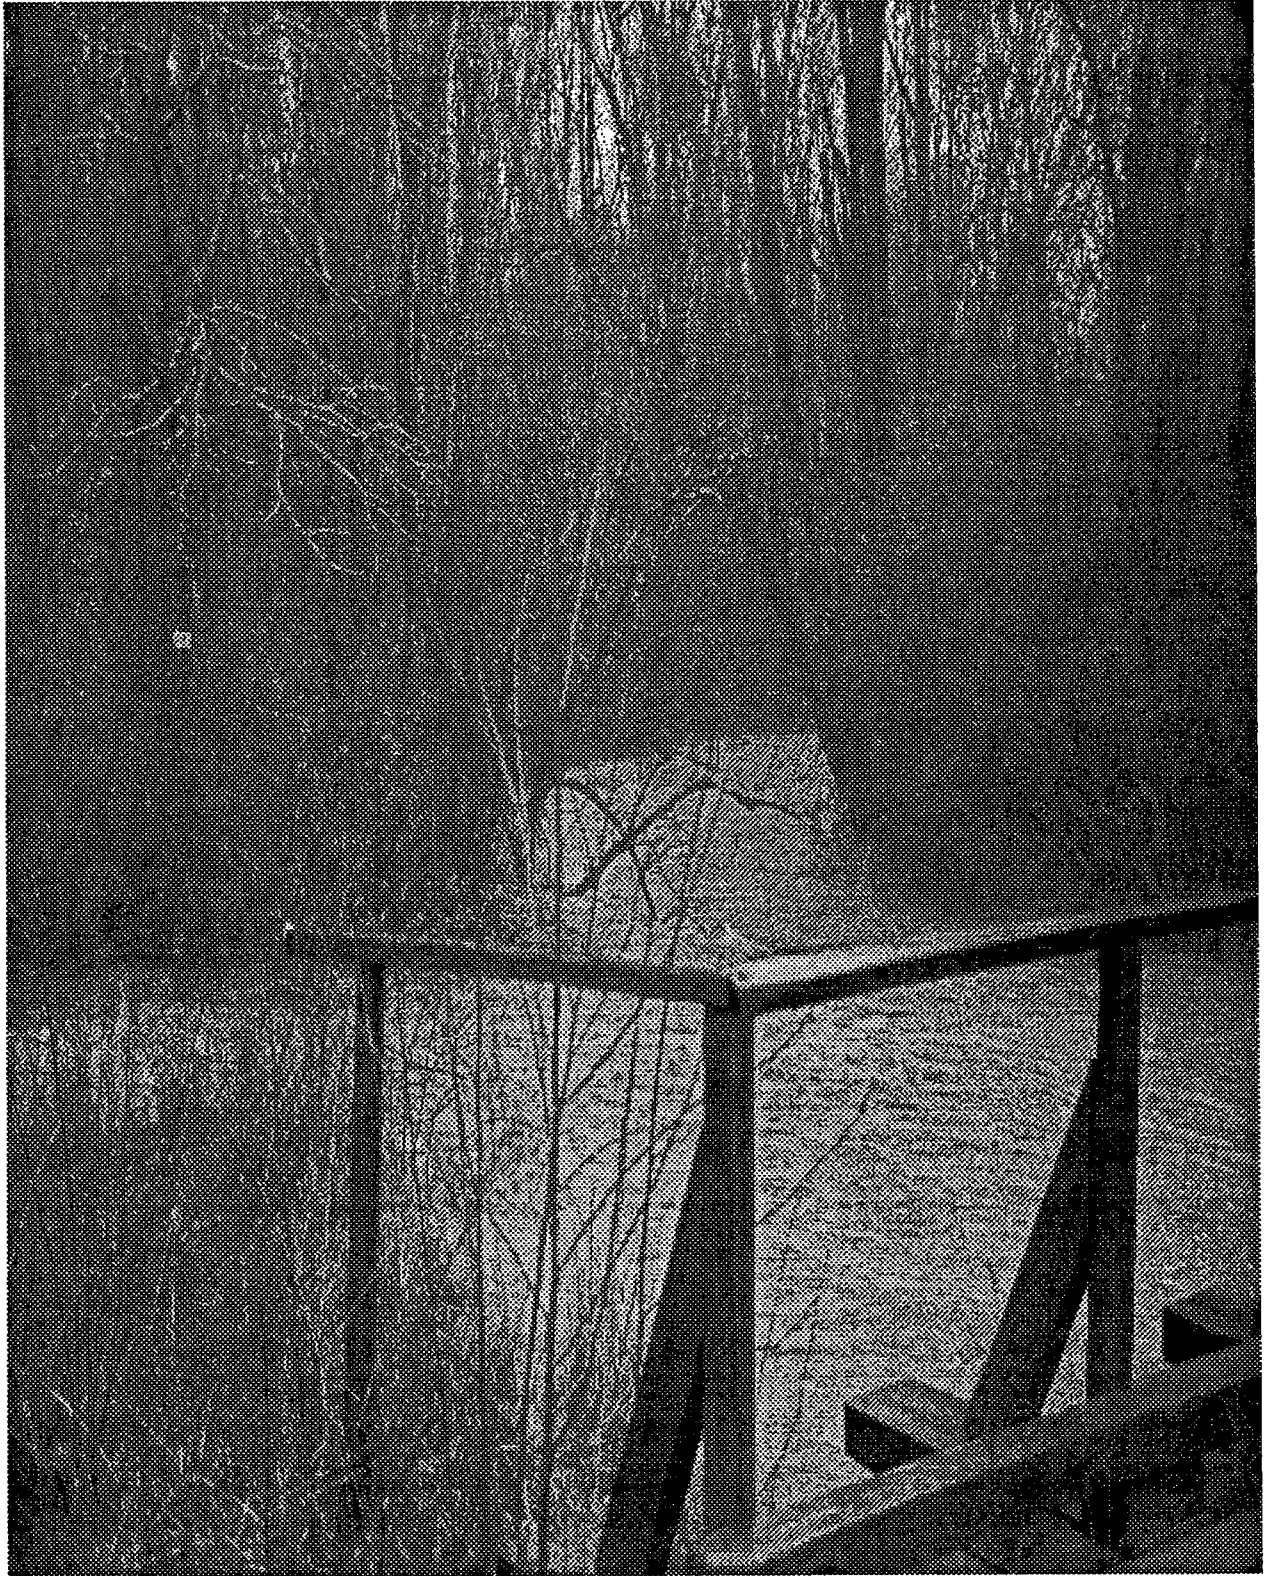
Photo D21 [3/5/98-9:55]

Pelham Range; this photograph (shot to the east) depicts Cane Creek during a storm event. The photograph is taken from bridge 9401.

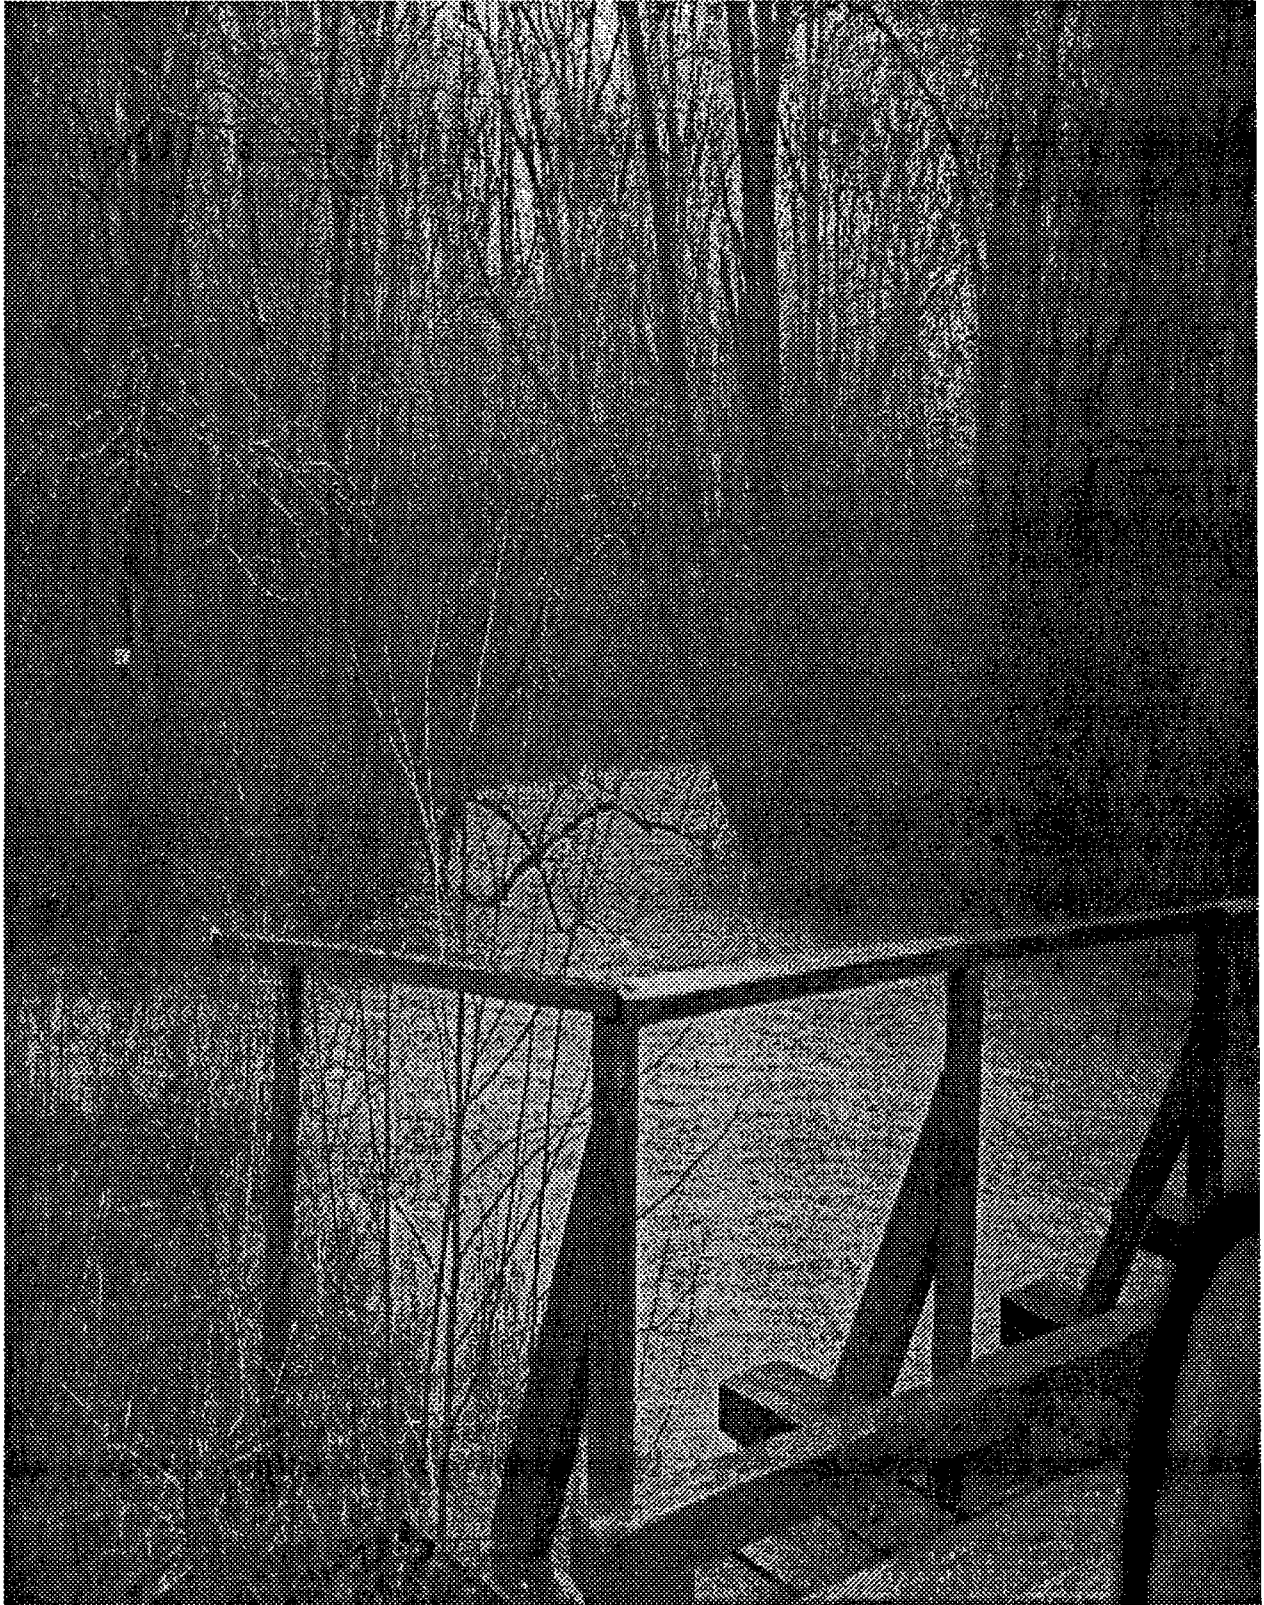
Photo E1 [3/5/98-9:58]

Same as D21; grey bat habitat for foraging.

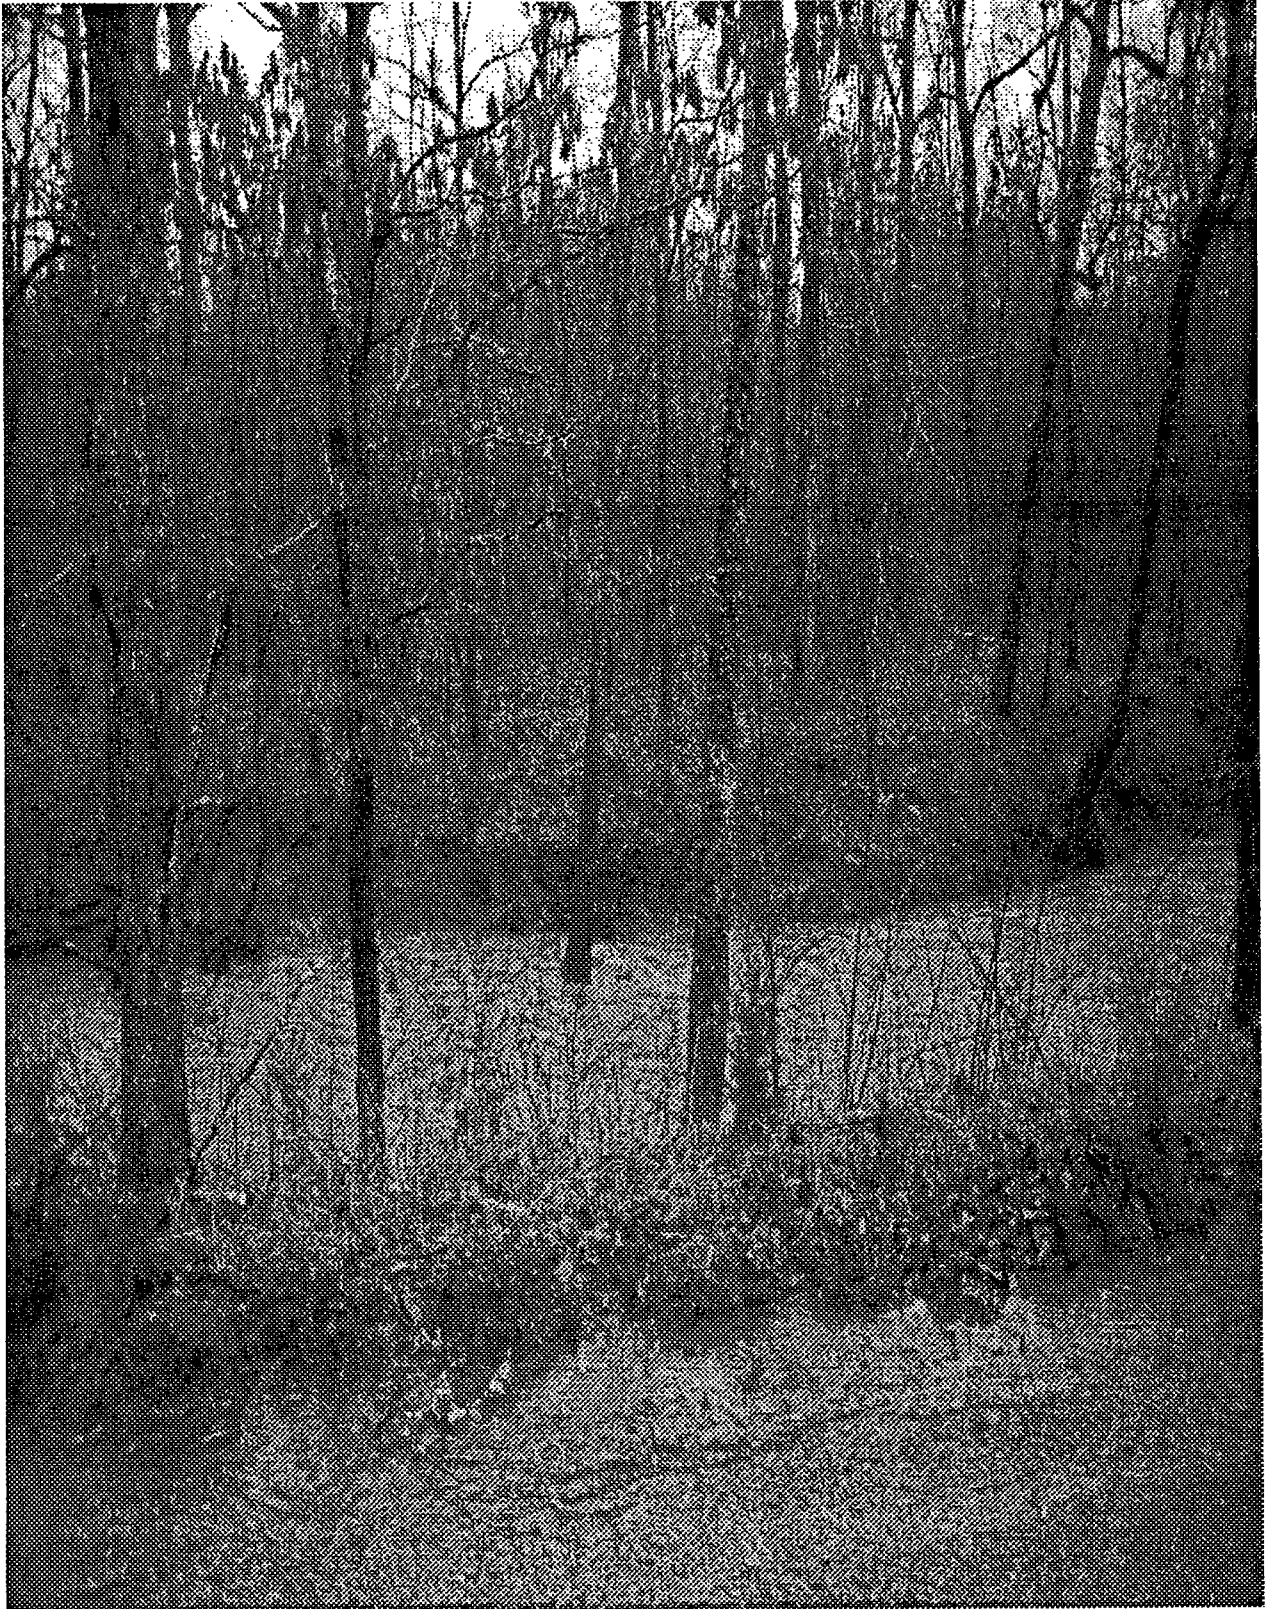
Photo E2 [3/5/98-10:02]

Pelham Range; this photograph (shot to the west) depicts Cane Creek along the roadway during a storm event.

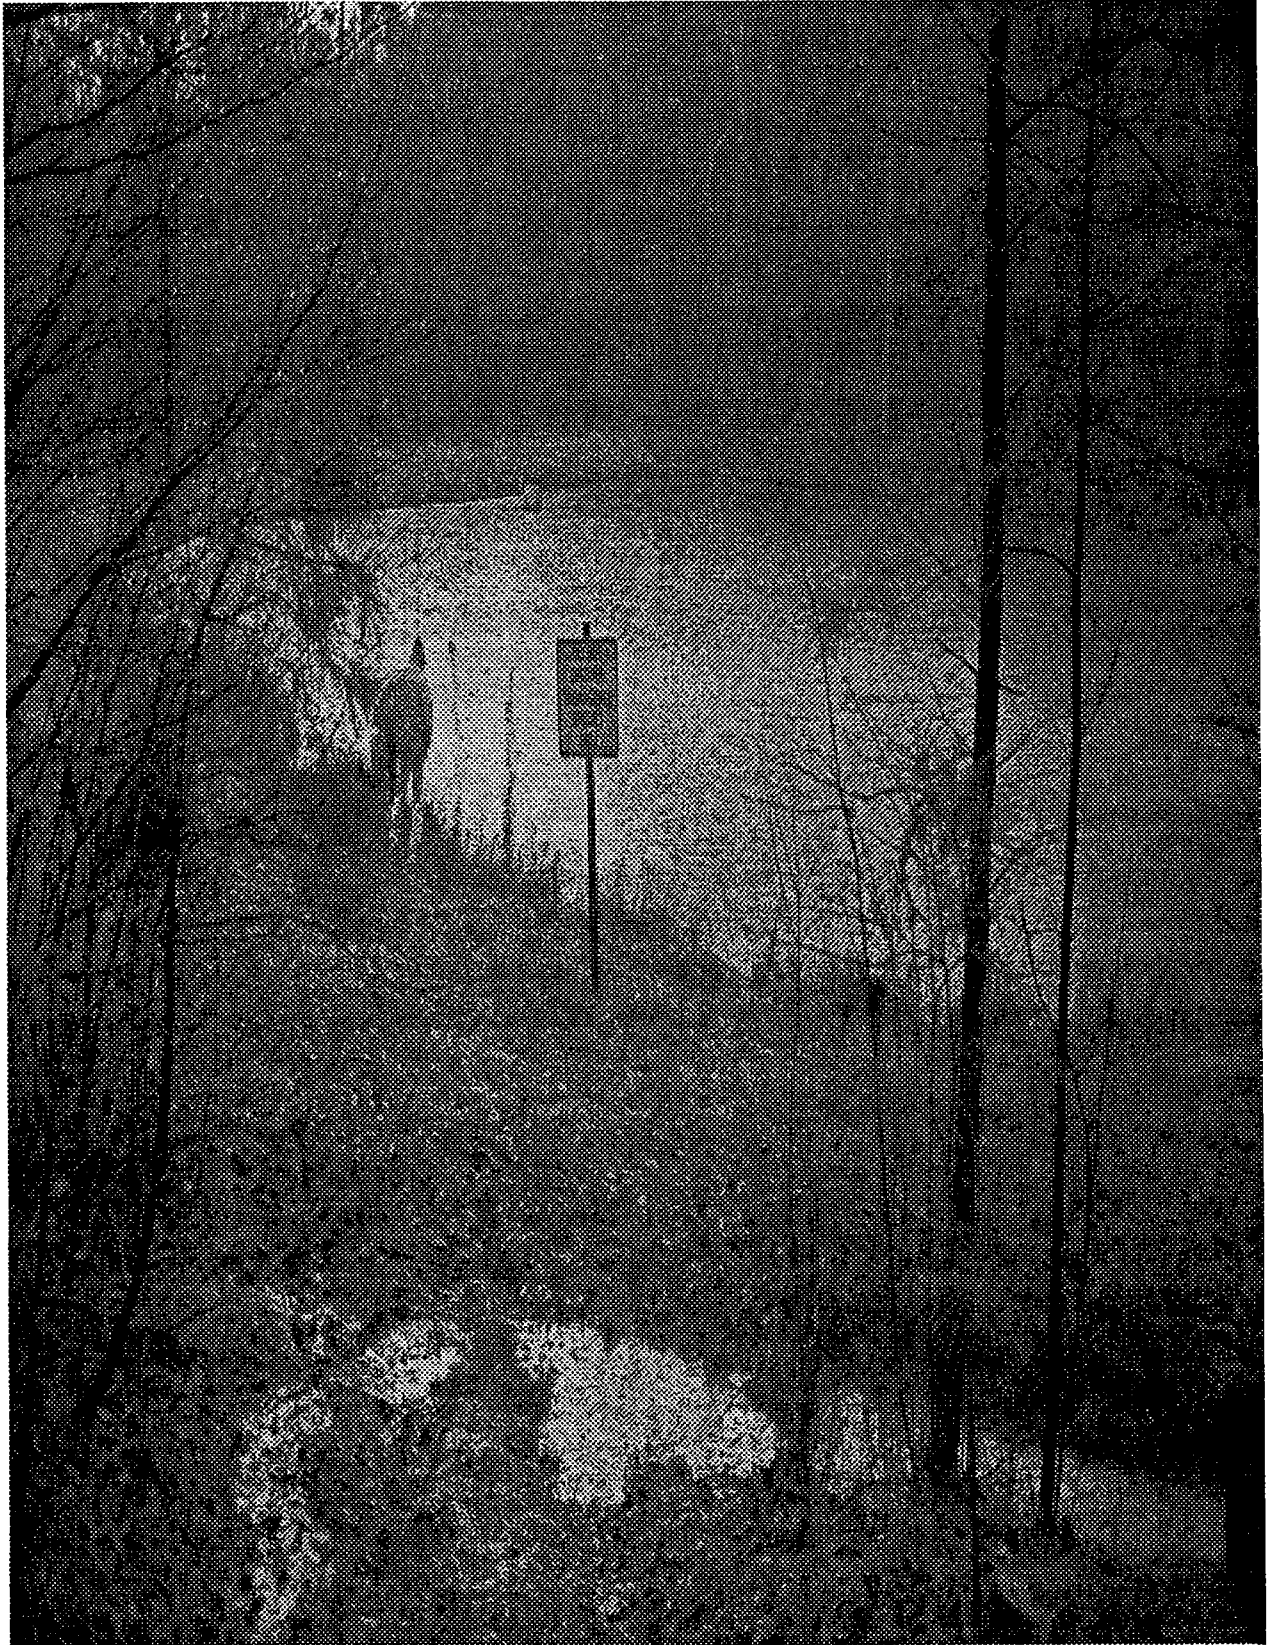
Photo E3 [3/5/98-10:05]

Pelham Range; wetlands area (spring fed) at the end of a dead-end.

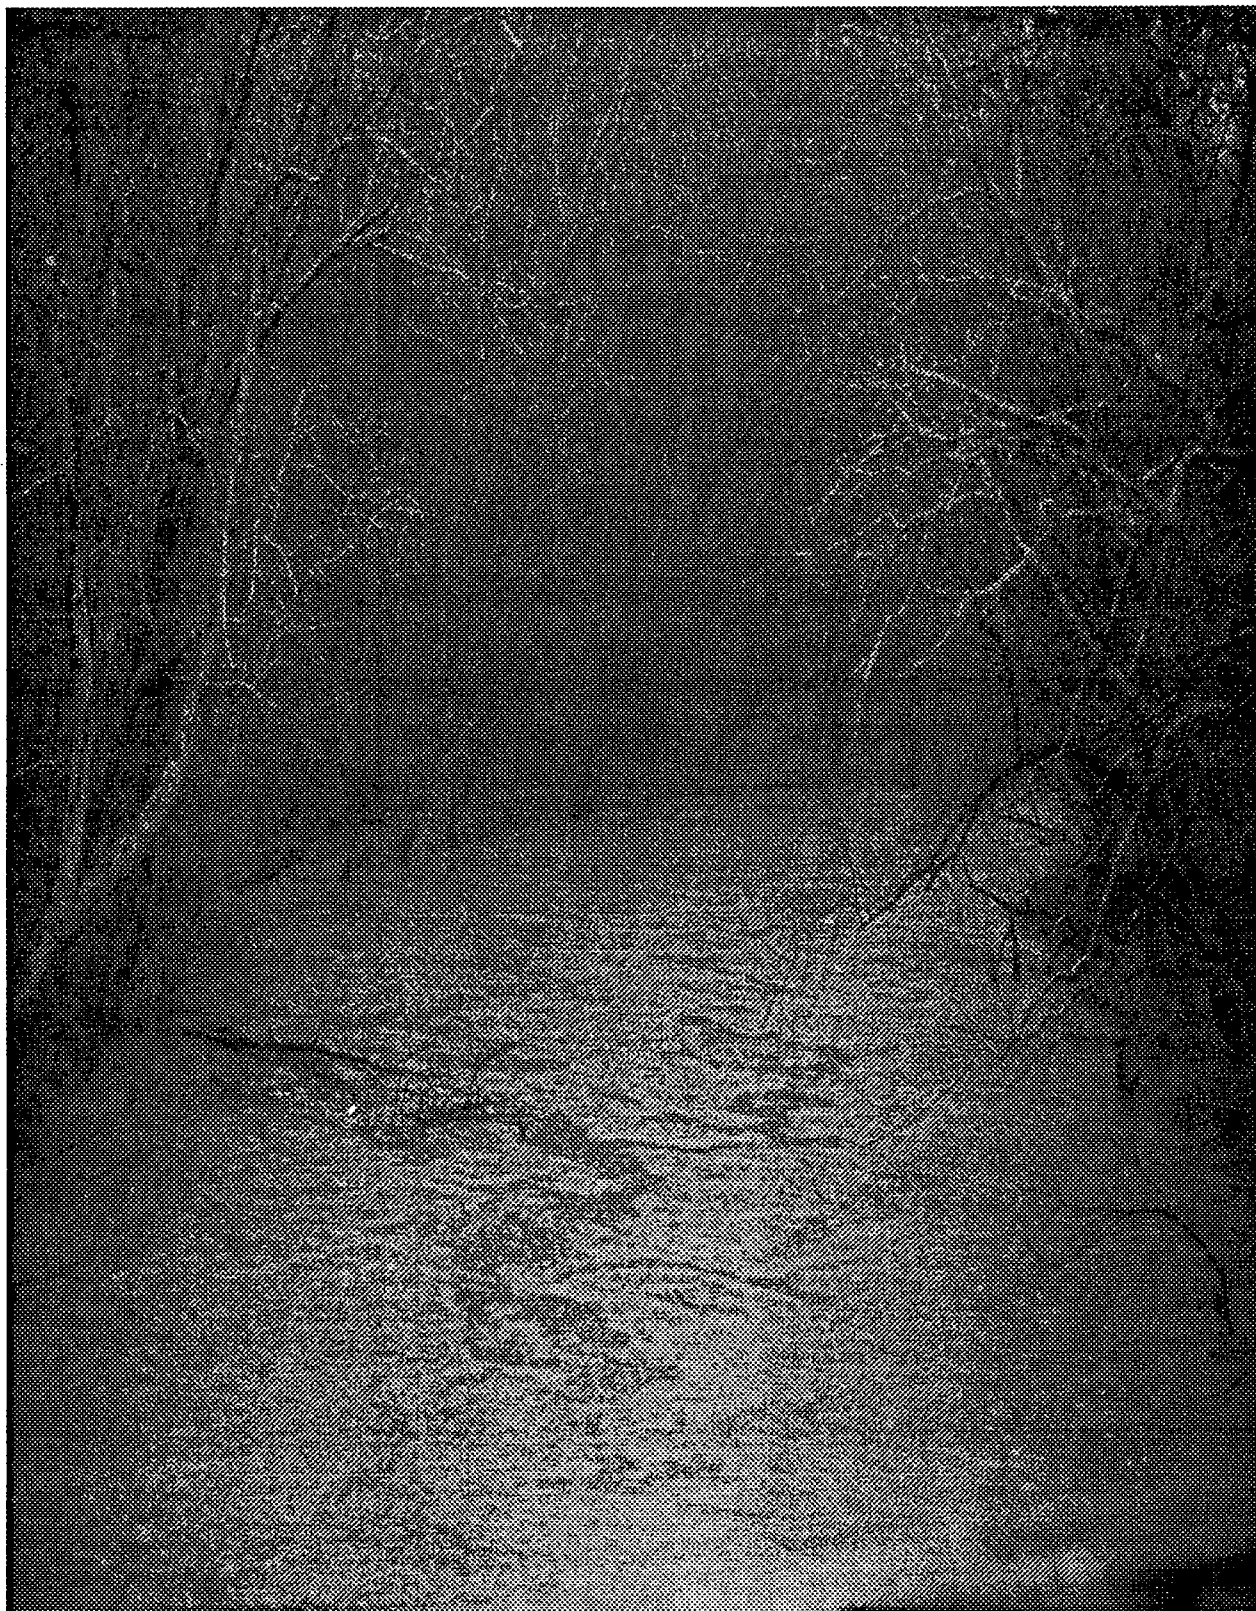
Photo E4 [3/5/98-10:20]

Pelham Range; Cane Creek from bridge 8210.

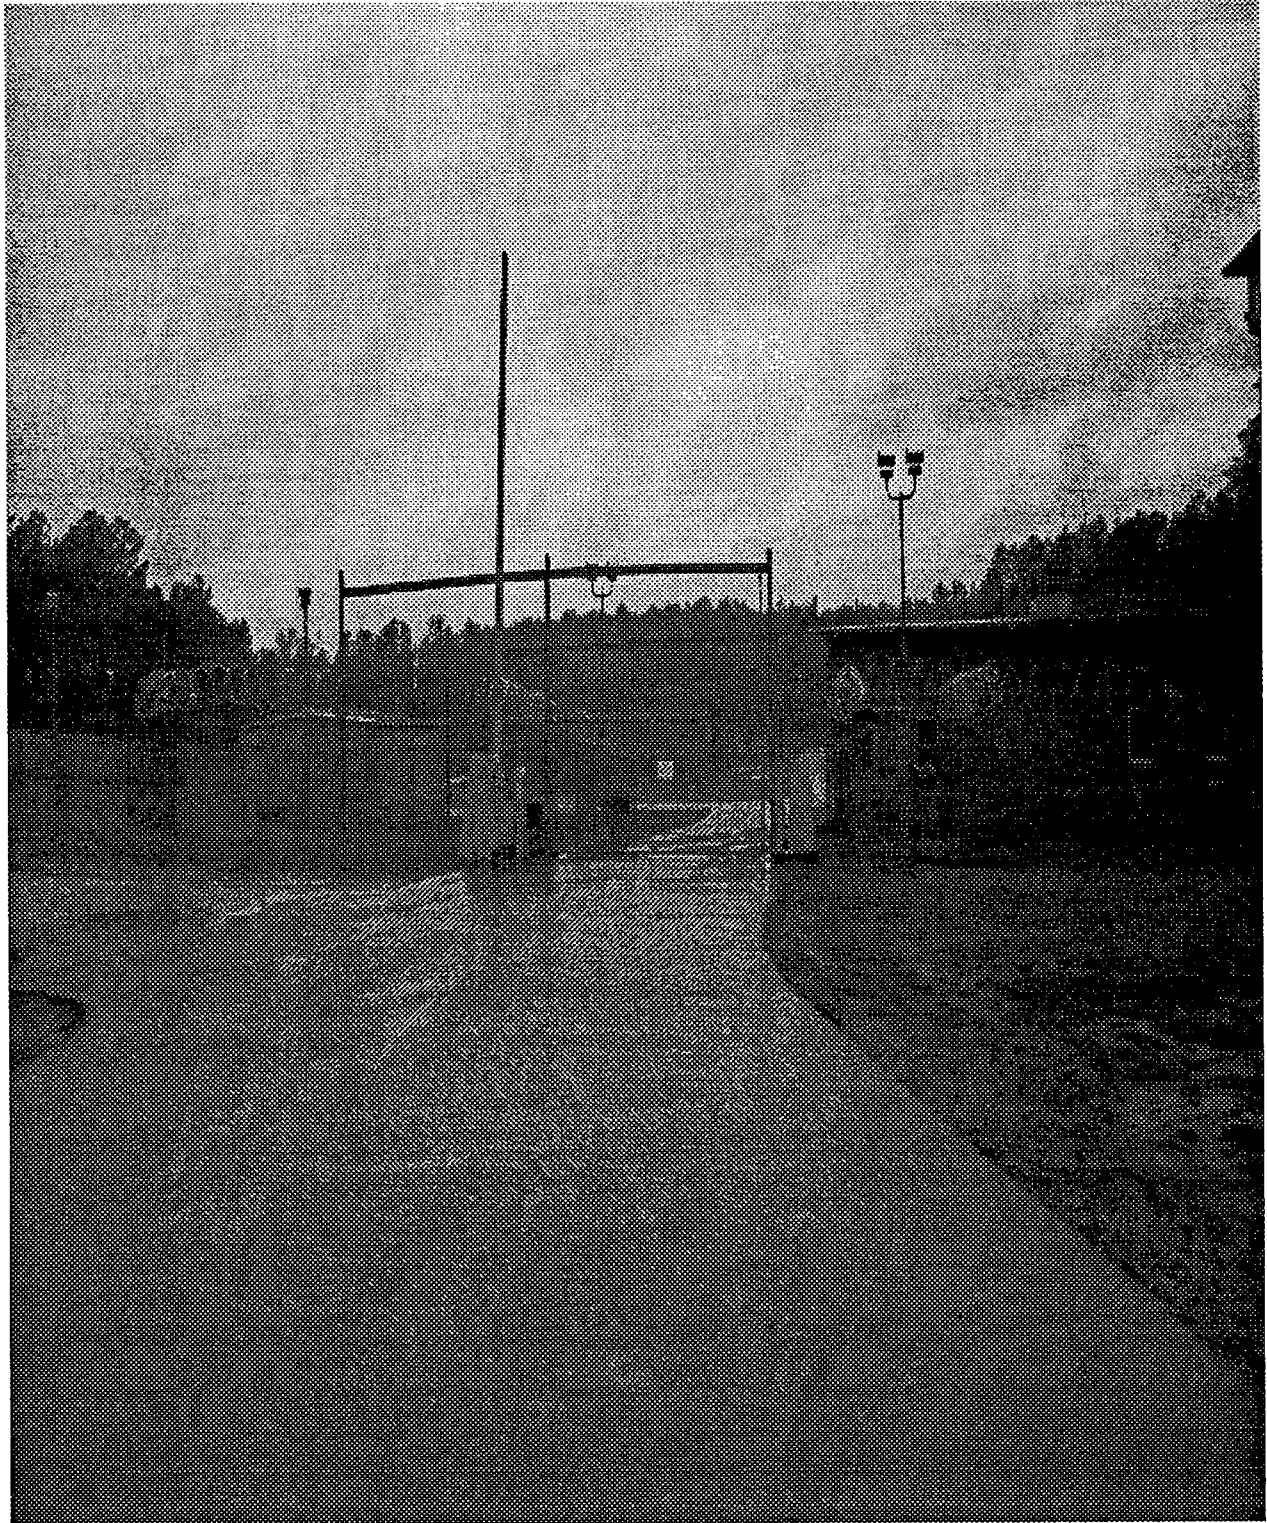
Photo E5 [3/5/98-10:24]

Pelham Range; Security Operational Test Site (SOTS) bldg. 8605. Site 102(7) [CERFA Parcel Map 28,28]

This site is located in the central portion of the Pelham Range. The site tests sticky foam, solvents, and explosives in anti-terrorist operations. Drainage pattern around site is unknown. Site is surrounded by forest. Area is marked by barbed-wire chainlink fence. A site walk was not possible due to the site being a restricted area.

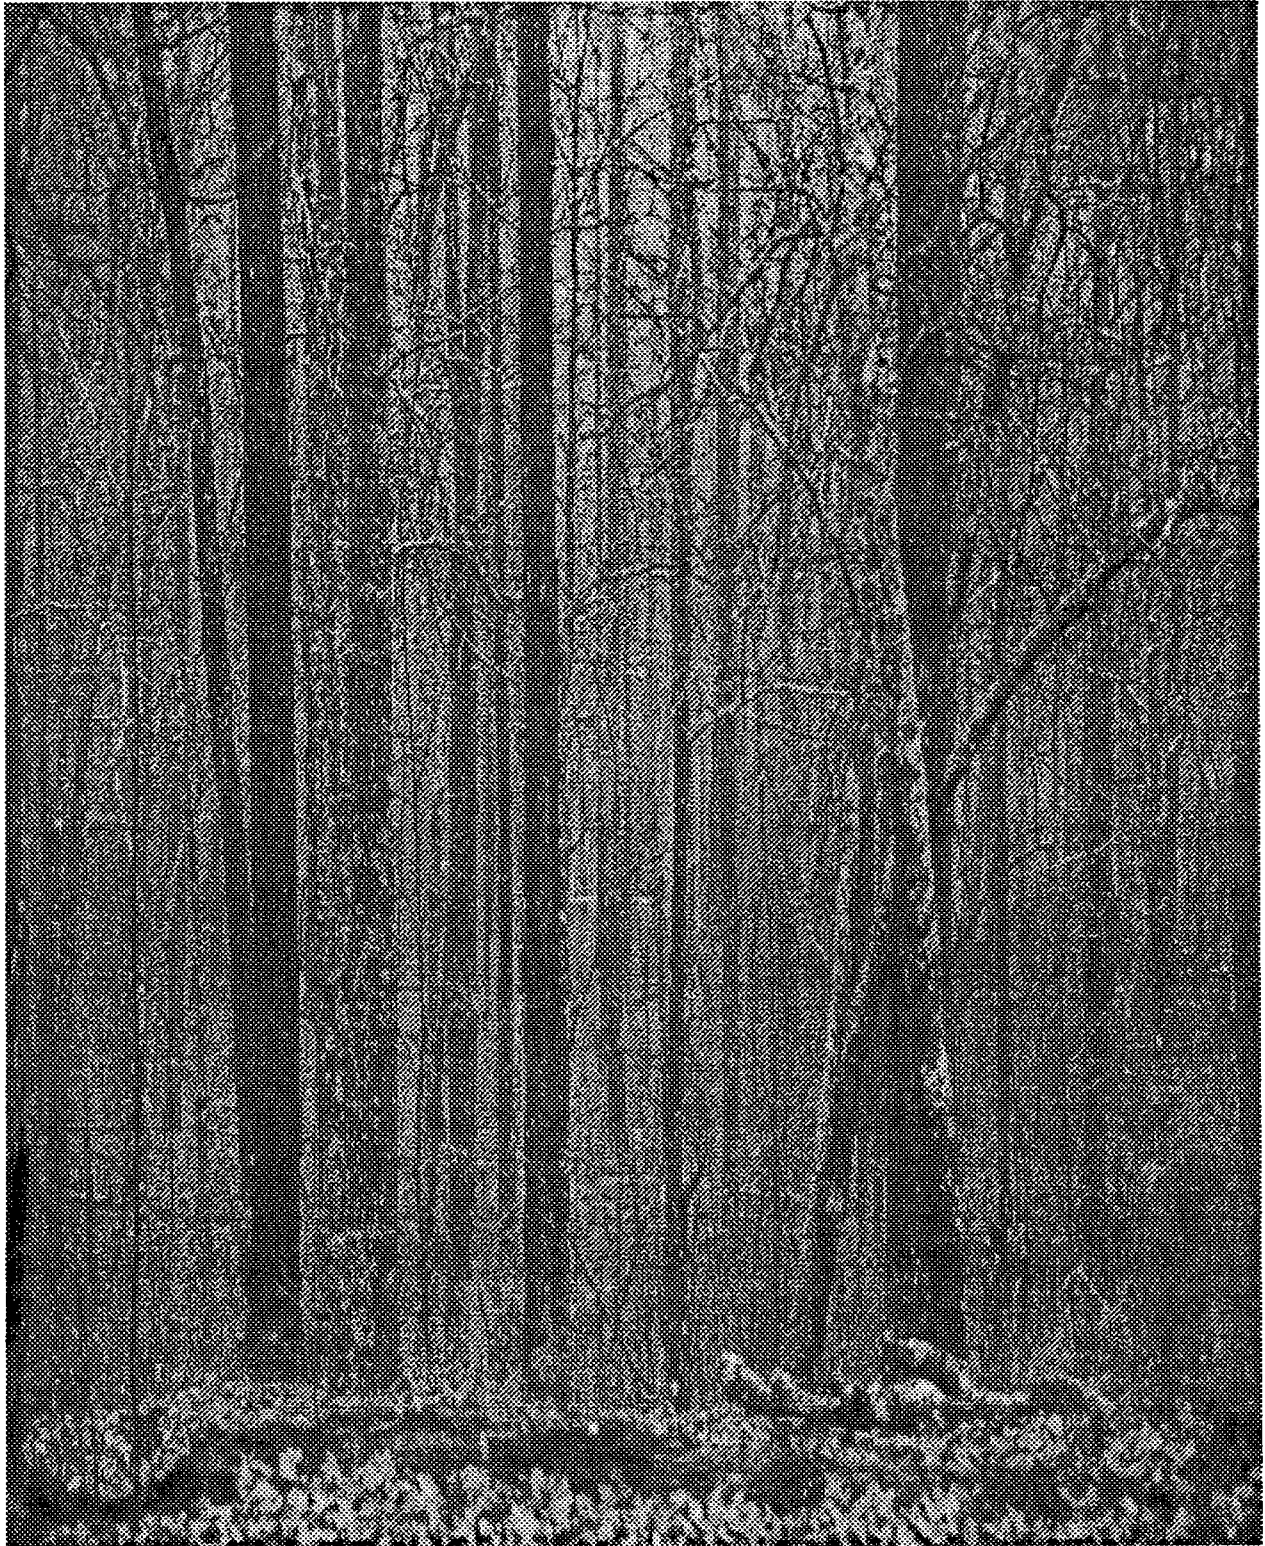
Photo E6 [3/5/98-10:38]

Old Water Hole, Pelham Range; Toxic Chemical Storage Site 205(7) [CERFA Parcel Map 45,42]

The site is located in the north-central region of Pelham Range. It is a very heavily wooded area. Two GW monitoring wells were noted at the site.

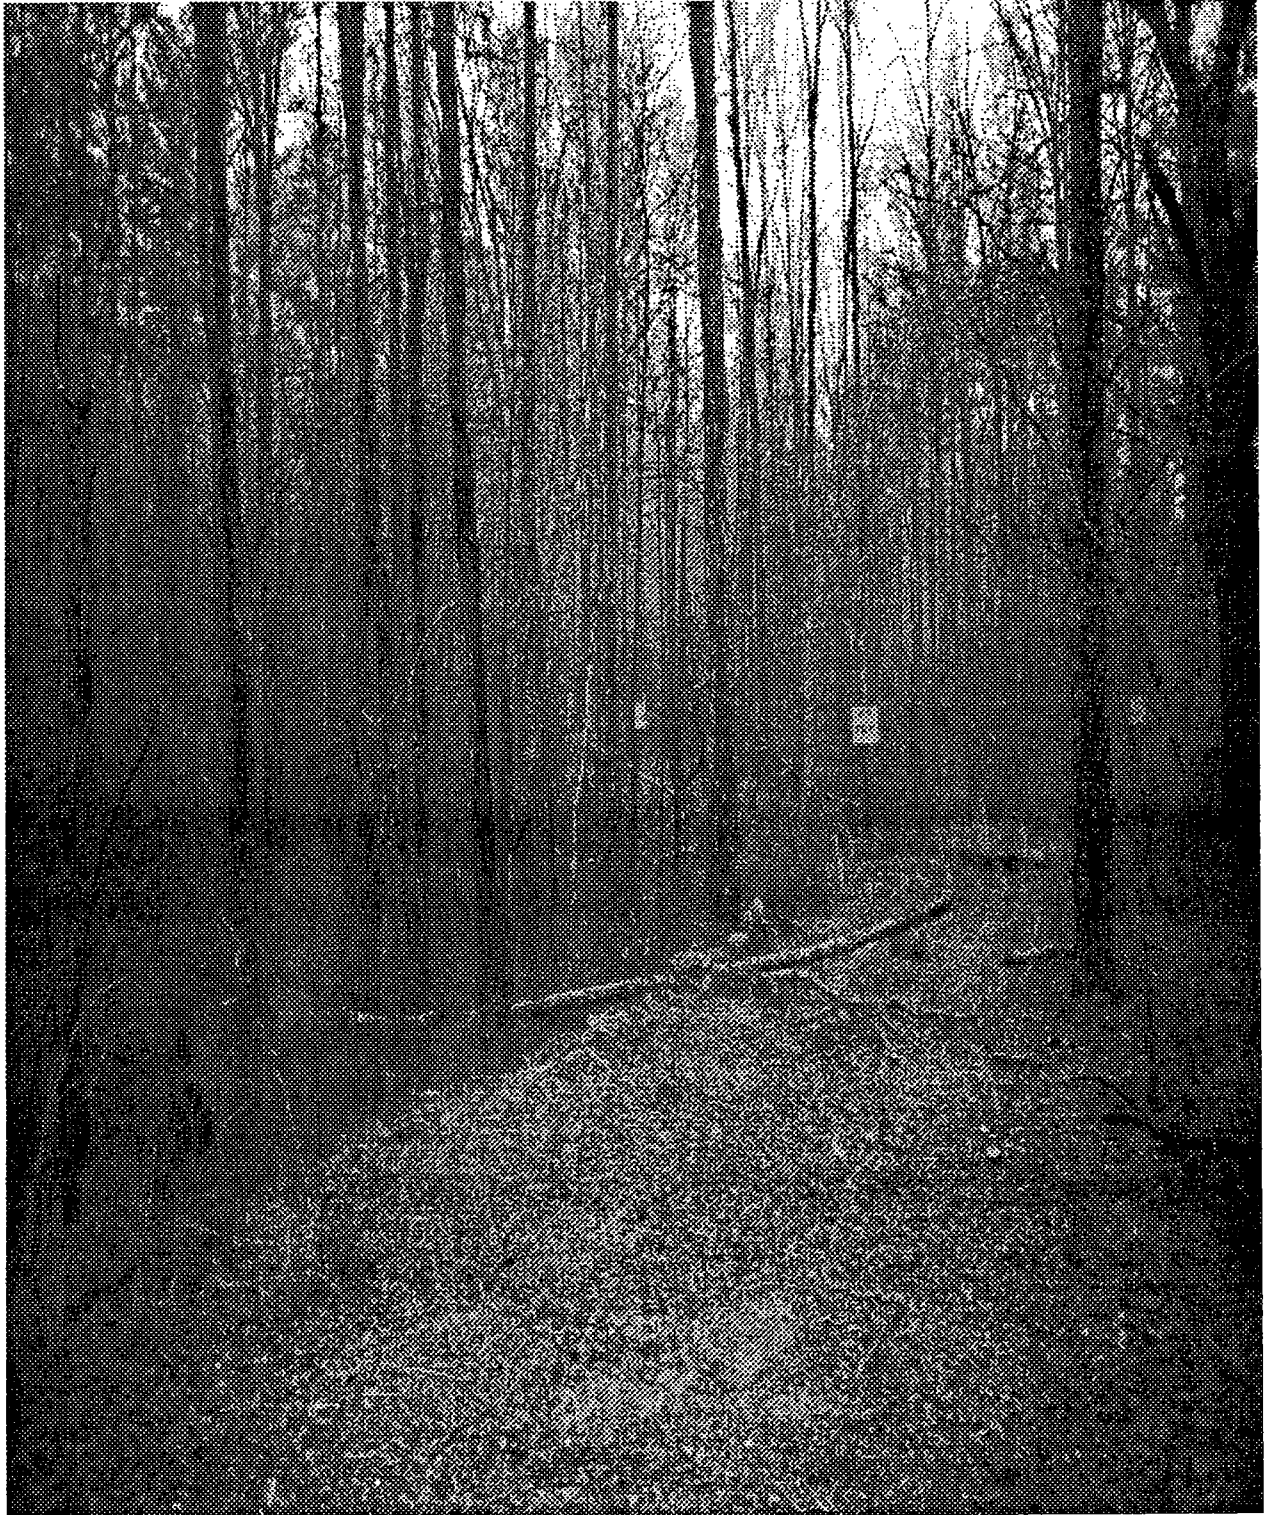
Photo E7 [3/5/98-10:40]

The site is located in the north-central region of Pelham Range. It is a very heavily wooded area. Two GW monitoring wells were noted at the site. This photograph (shot to the N) is a lower elevation of the previous site (205(7)). Potential wetland/flooded area in the forested area to the left in the photograph.

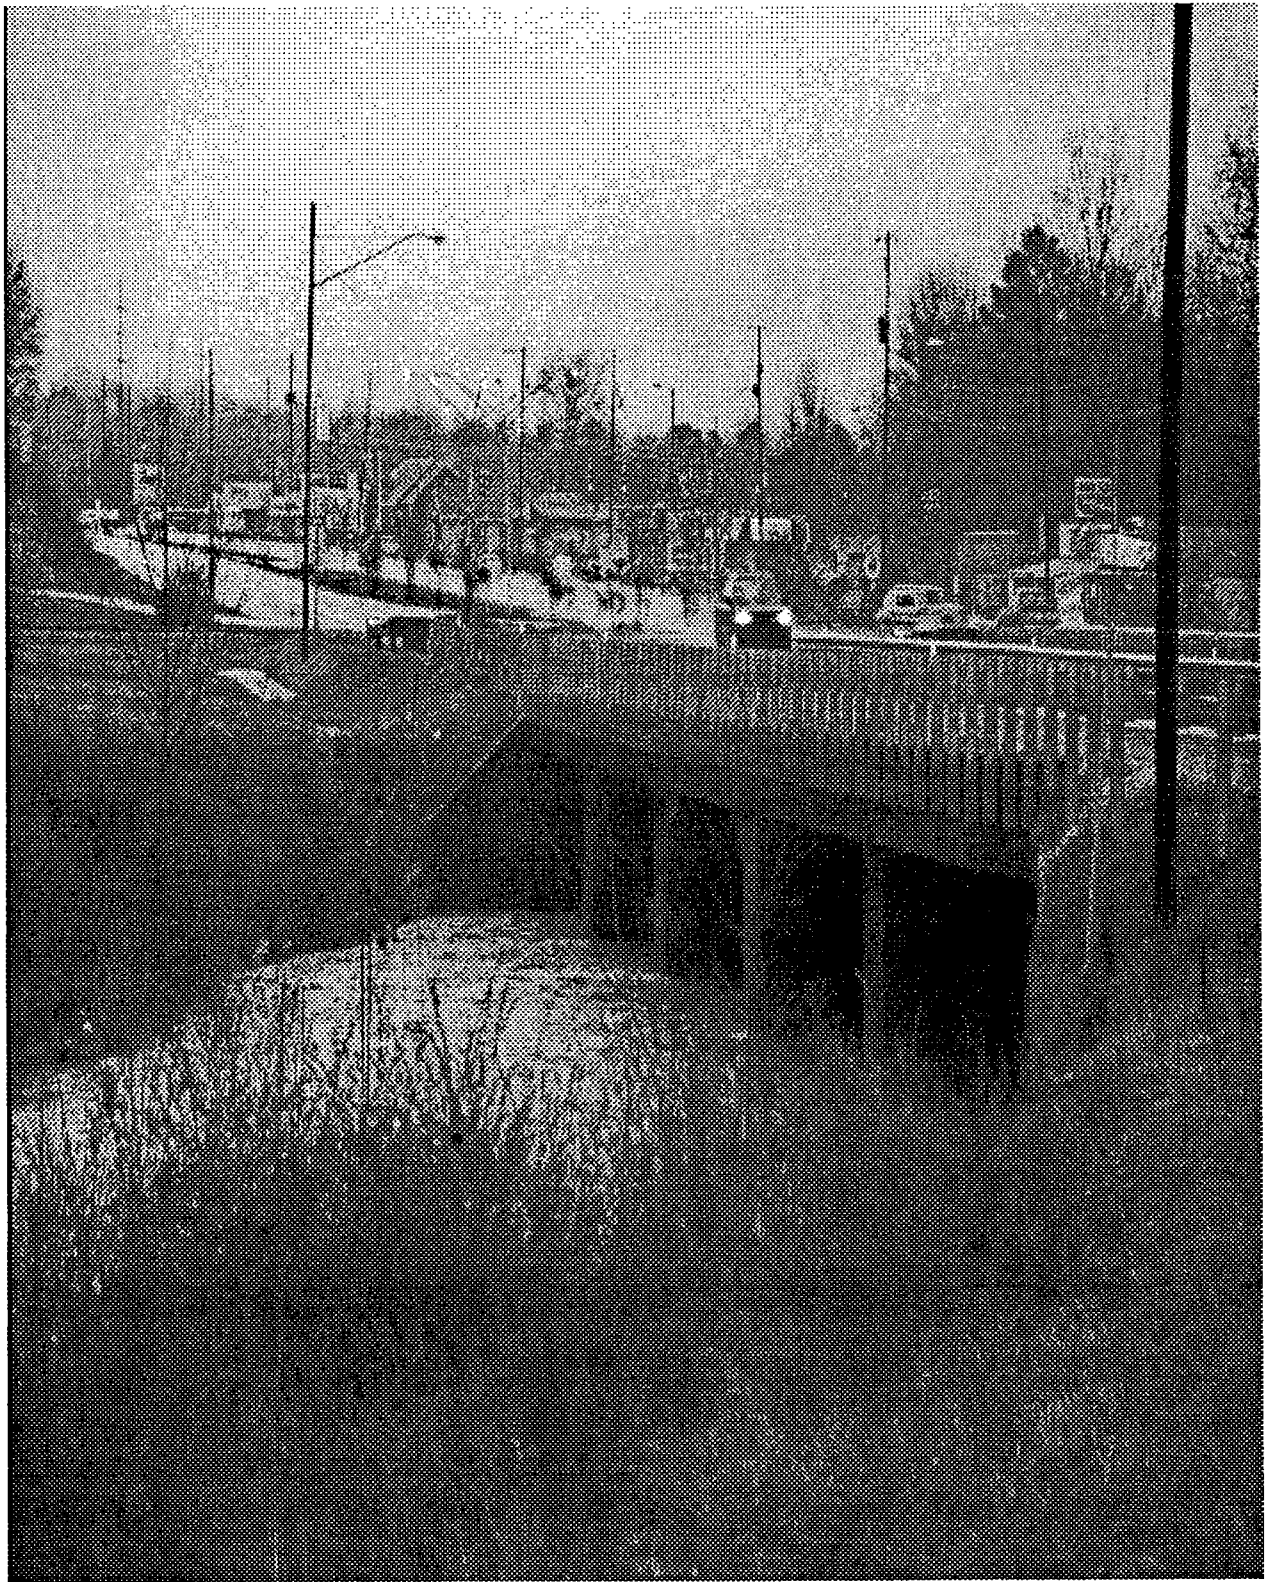
Photo E8 [3/5/98-11:05]

Rt. 21 bridge over Cane Creek; Grey Bat roost site. This site is just outside of the Main Post and the photo shows Cane Creek during a storm event. The bridge shown in the photograph provides a roosting area for the Grey Bat.

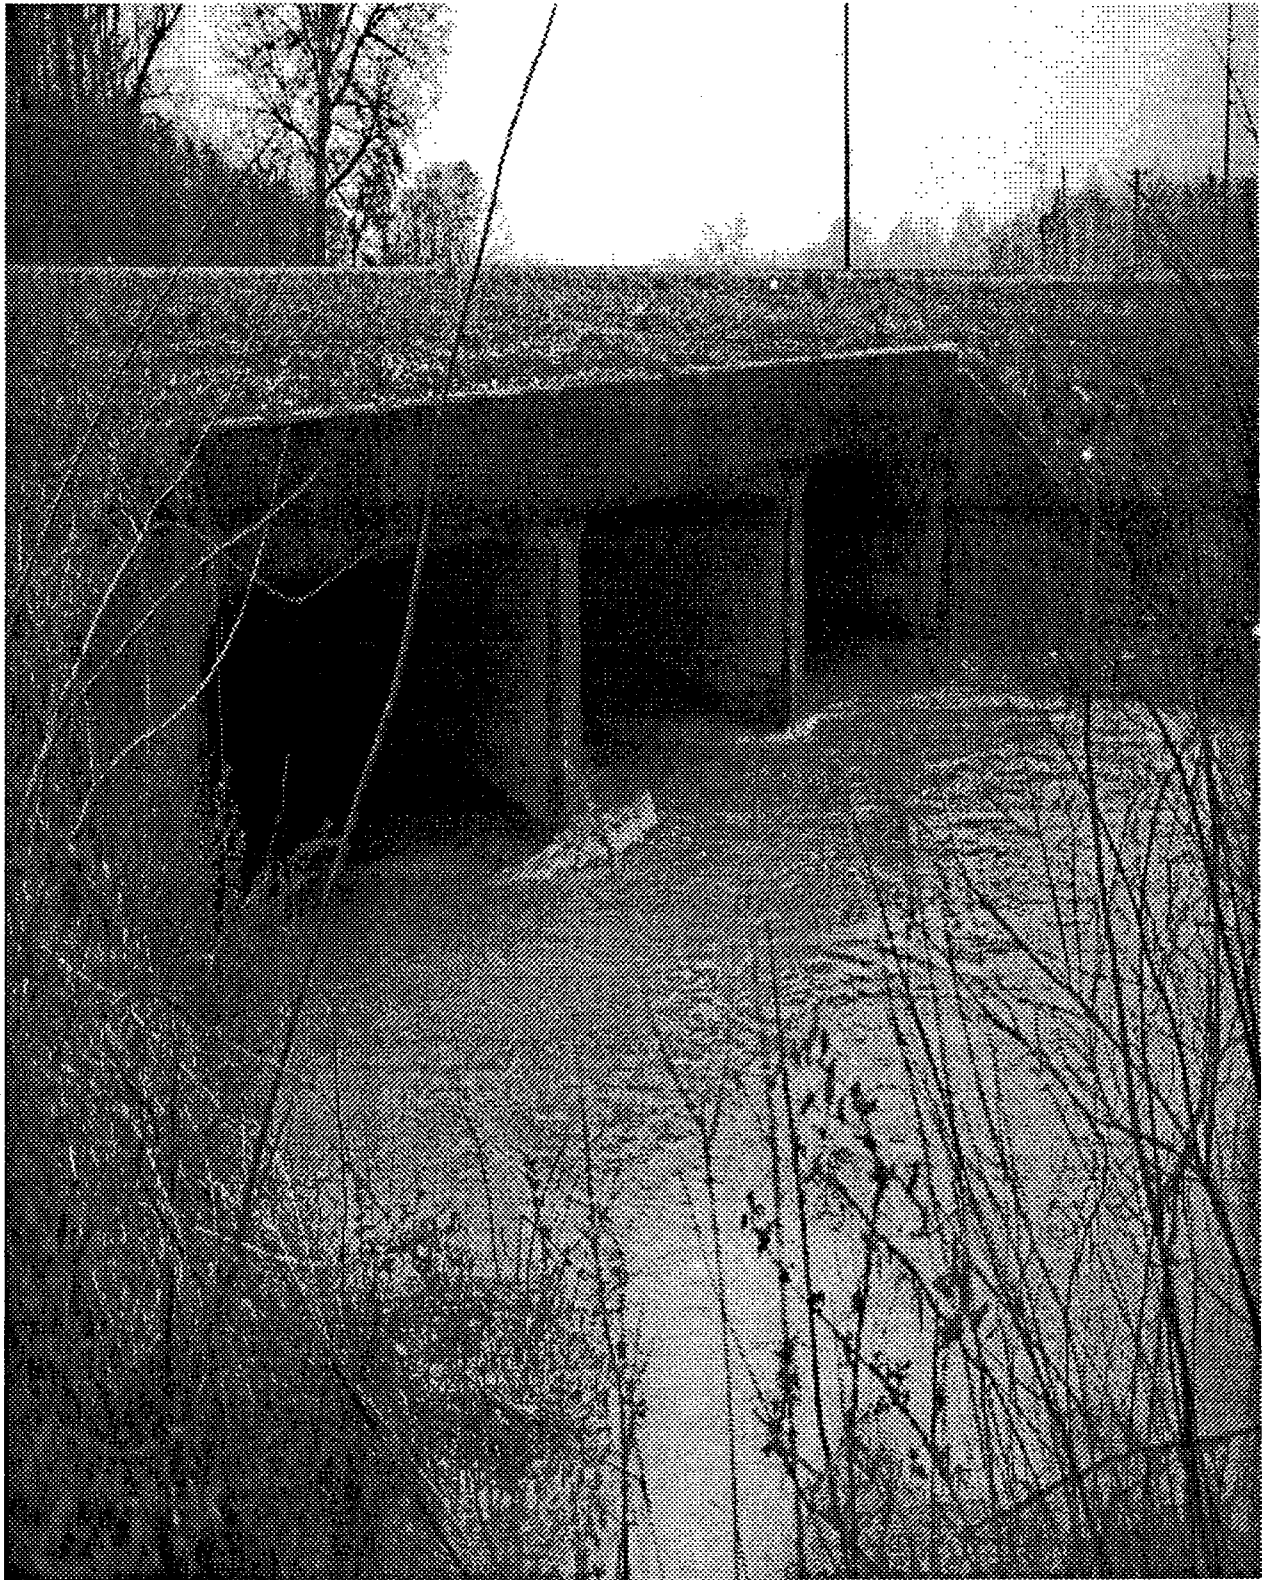
Photo E9 [3/5/98-11:08]

Rt. 21 bridge over Cane Creek; Grey Bat roost site. This site is just outside of the Main Post and the photo shows Cane Creek during a storm event. The bridge shown in the photograph provides a roosting area for the Grey Bat.

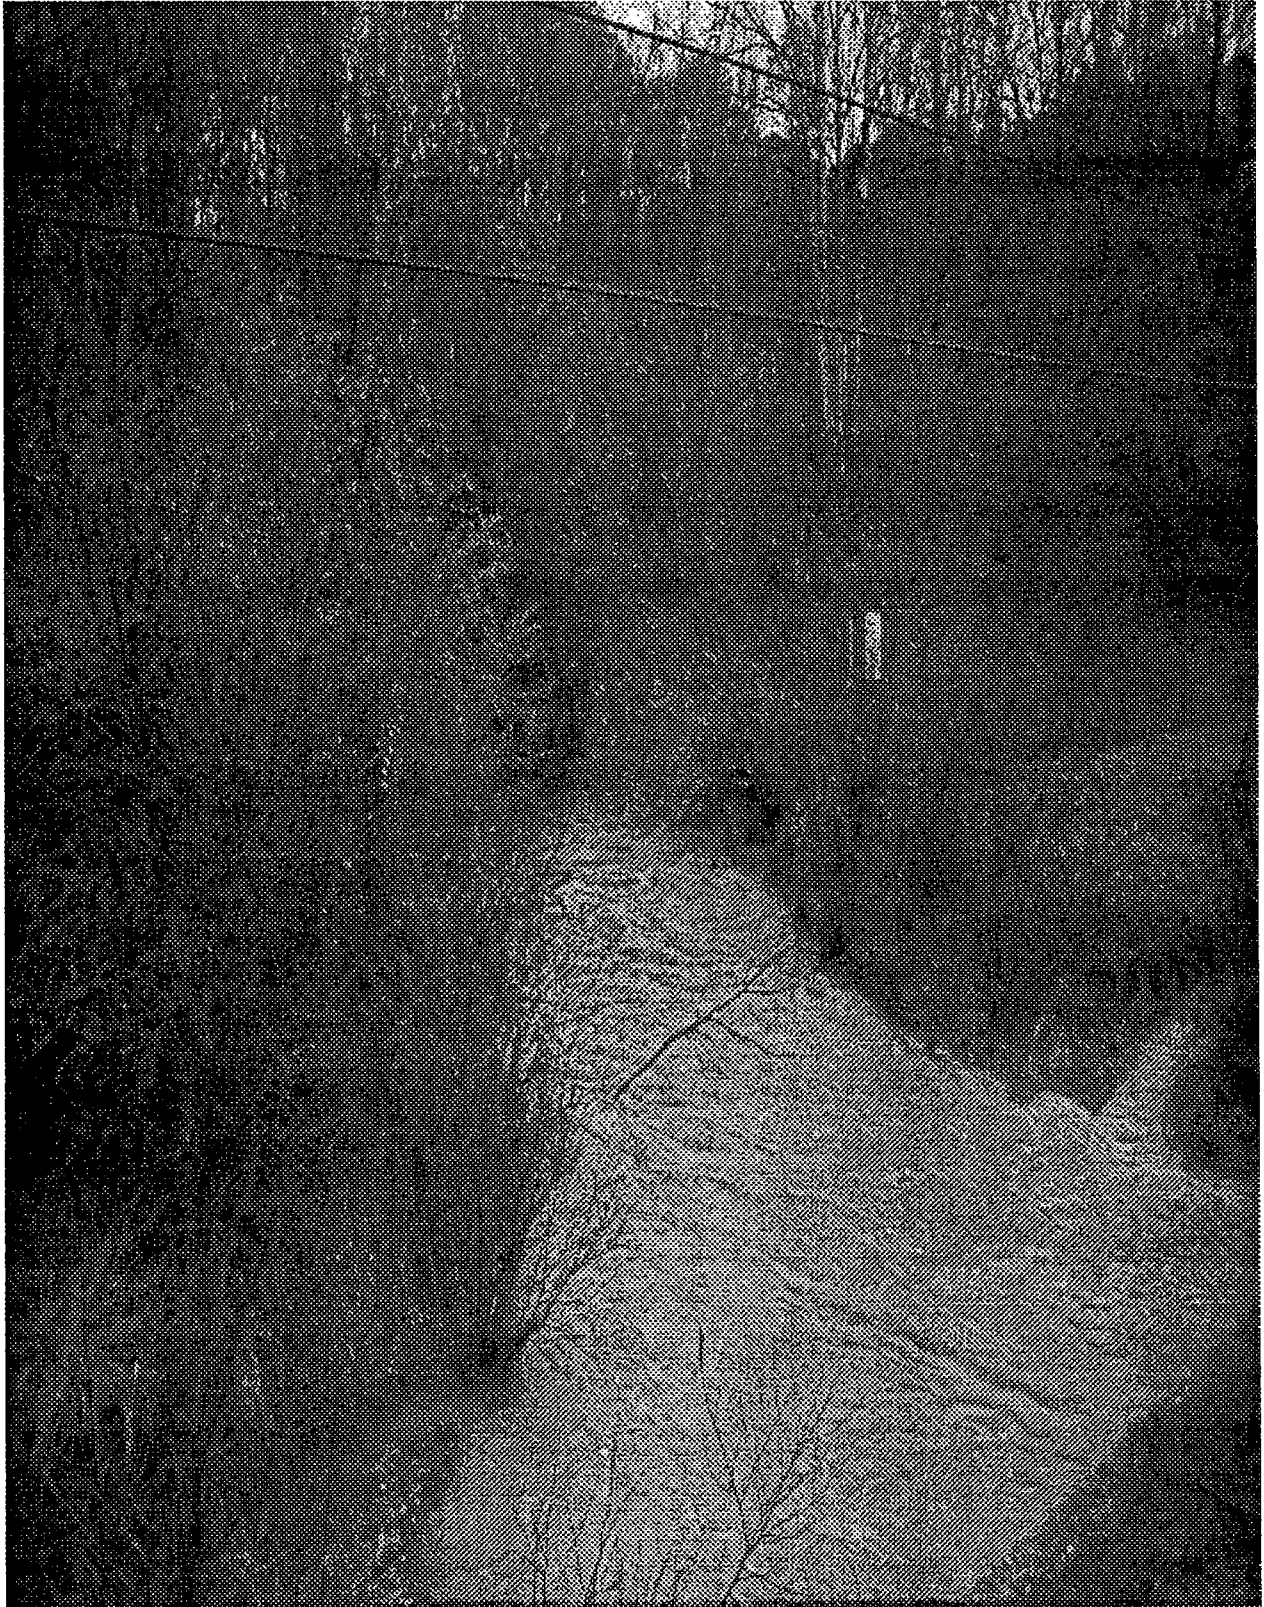
Photo E10 [3/5/98-11:10]

Same bridge as E9 looking upstream into Cane Creek.
